Revised
FULL RESERVE STUDY
Heron Lakes
Townhome Association, Inc.

Houston, Texas
Inspected - November 15, 2016
Revised - March 24, 2017

Client: Heron Lakes Townhome Association, Inc. (Heron Lakes)

Reference: 060490

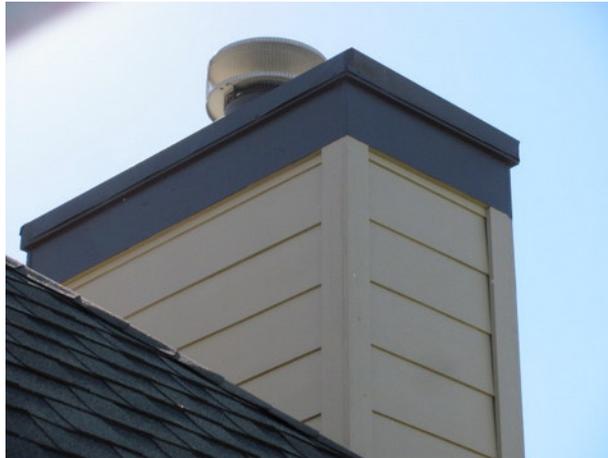
Chimney Caps, Metal - Heron Lakes maintains 84 metal chimney caps. The chimney caps are original and in good overall condition based on our visual inspection from the ground.

Chimney cap

Chimney caps of this type have useful lives of up to 25 years. We recommend the Association anticipate a phased replacement of the chimney caps and related flashing beginning by 2027 and concluding by 2028 in coordination with the roofs. We depict this information on Line Item 1.140 of *Reserve Expenditures*. We recommend the Association inspect the condition of the chimney caps concurrent with replacement of the roof systems.

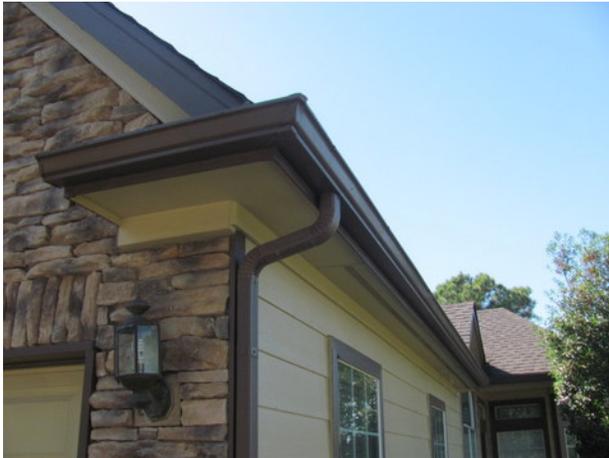
Gutters and Downspouts, Aluminum - Approximately 10,350 linear feet of aluminum six-inch seamless gutters and three-inch by four-inch downspouts drain storm water from the roofs of Heron Lakes. These gutters are original and in good to fair overall condition. The downspouts were replaced in 2016.

Gutters and downspouts

The useful life of gutters and downspouts coincides with that of the asphalt shingle roofs at 15- to 20-years. Therefore, we recommend the Association budget for the phased replacement of the gutters and downspouts in conjunction with the roof replacement beginning by 2027 and concluding by 2028. This will result in the most economical unit price and minimize the possibility of damage to other roof components as compared to separate replacements. A subsequent phased replacement is likely beginning by 2045 and concluding by 2046. We depict this information on Line Item 1.240 of *Reserve Expenditures*. We base our cost on replacement with .027-inch thick aluminum.

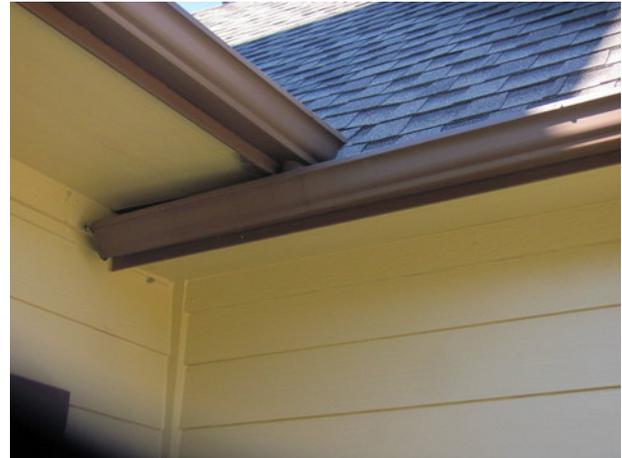
Gutters

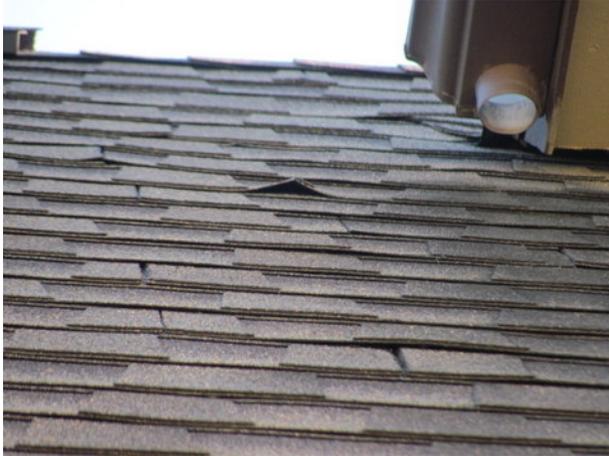
Roofs, Asphalt Shingles - Approximately 2,100 *squares*¹ of asphalt shingles comprise the roofs of Heron Lakes. The roofs are in good to fair overall condition at an age of seven years. Management does not report a history of leaks. Our visual inspection from the ground notes shingle lift, sheathing deflection, roof stains and trees in contact with roofs. Trees in contact with exterior building elements may lead to damage and/or accelerated deterioration of

Asphalt shingle lift at building with Unit 10827

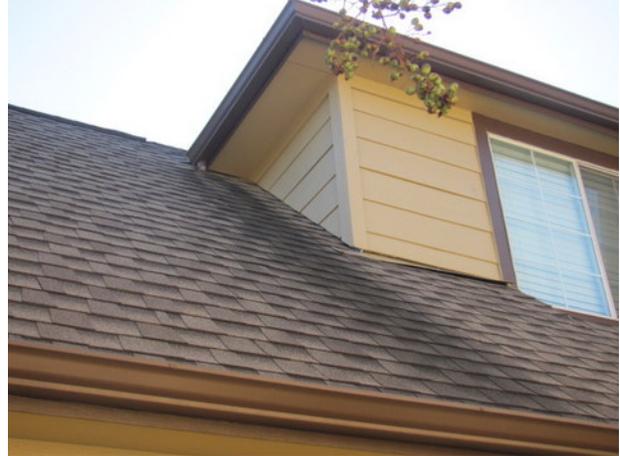
Roof stains at building with Unit 10843

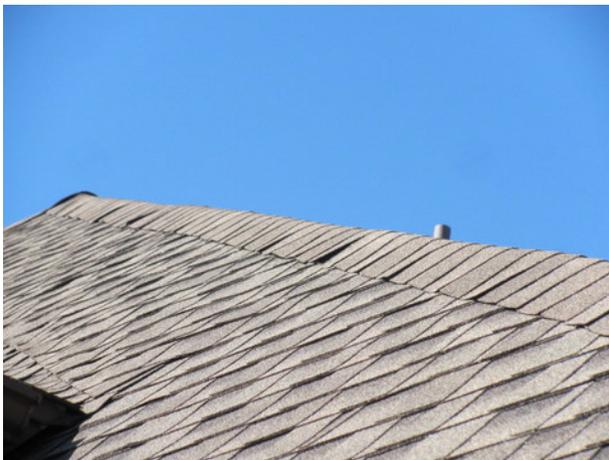
Asphalt shingle lift at building with Unit 10807

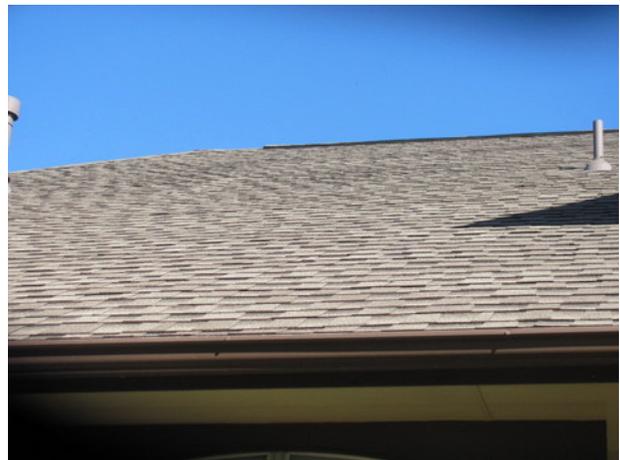
Asphalt shingle roof sheathing deflection at building with Unit 10830

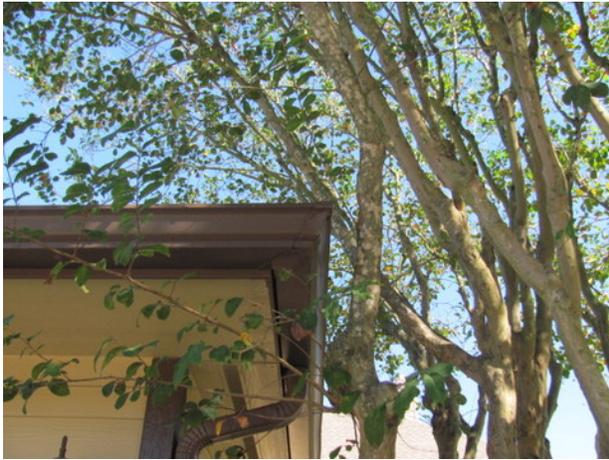
**Trees in contact with roof at building with Unit
10810**

these elements. We recommend the Association fund tree trimming through the operating budget on an as needed basis.

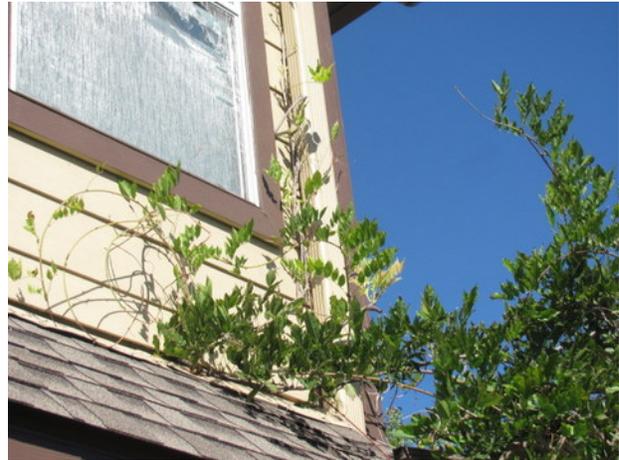
**Trees in contact with roof at building with Unit
10802**

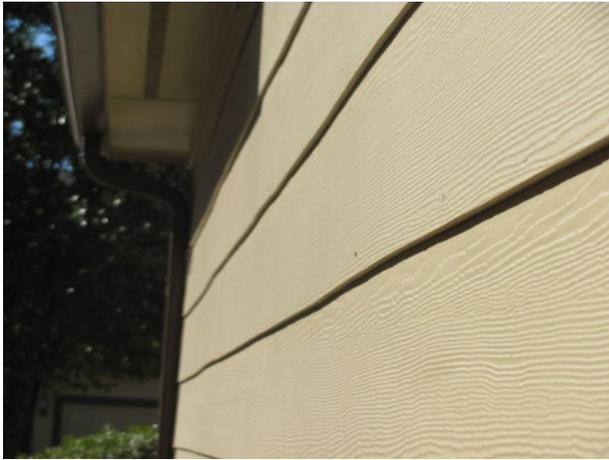
Siding paint finish in good condition

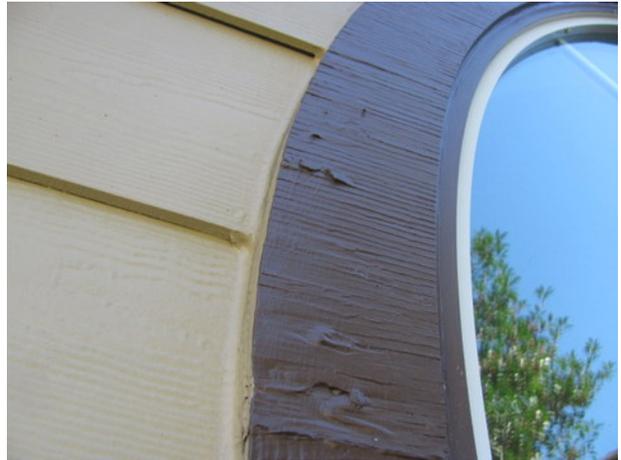
Isolated paint finish deterioration

Heron Lakes should budget subsequent applications and associated replacements every eight years thereafter. We depict this information on Line Item 1.760 of *Reserve Expenditures*.

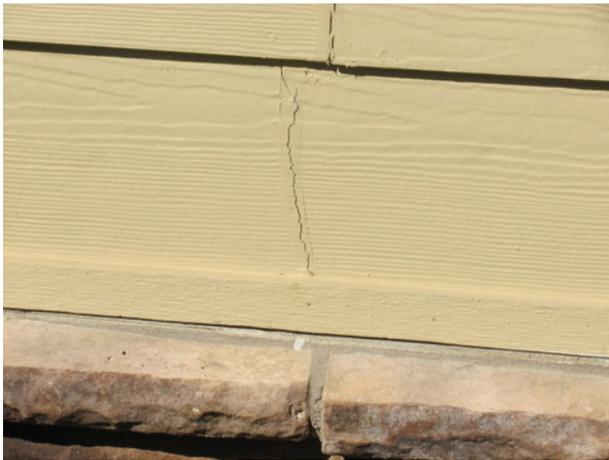
Fiber cement siding crack at building with Unit 10843

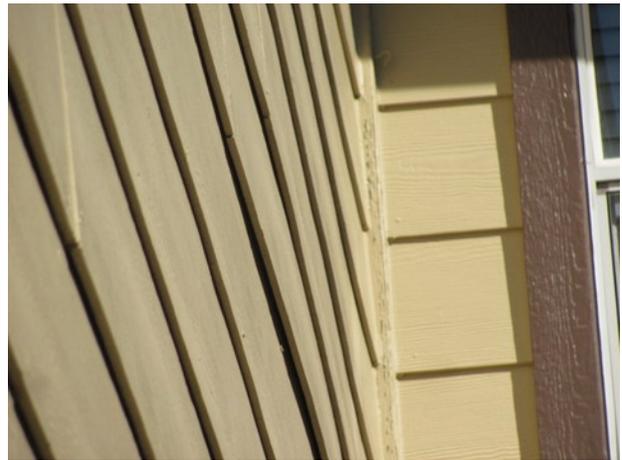
Fiber cement siding warp

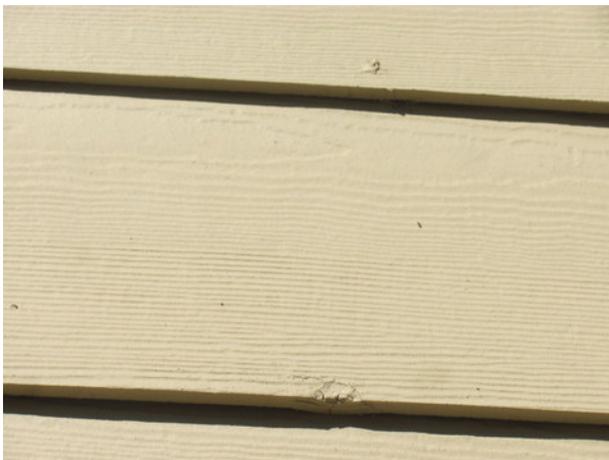
Isolated damaged fiber cement siding

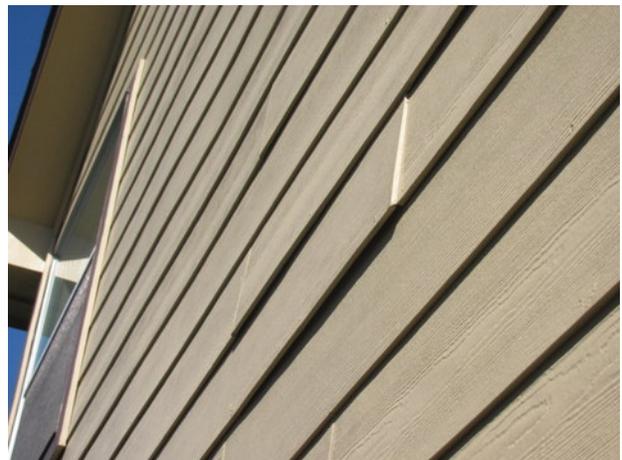
Fiber cement siding warp

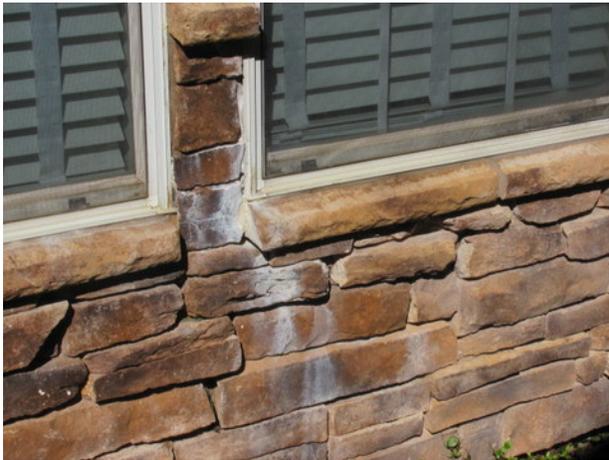
Efflorescence

We recommend the Association anticipate an inspection and capital repairs to this masonry veneer every 8- to 12-years. These components will require repairs as a result of efflorescence accumulation, delamination of the stone and mortar deterioration. We recommend Heron Lakes budget for a complete inspection of all the masonry veneer and repairs of less than one percent (0.5%) by 2023 and every eight years thereafter in coordination with paint finishes at the buildings. Line Item 1.800 of *Reserve Expenditures* notes our estimate of future costs and anticipated times of capital repairs.

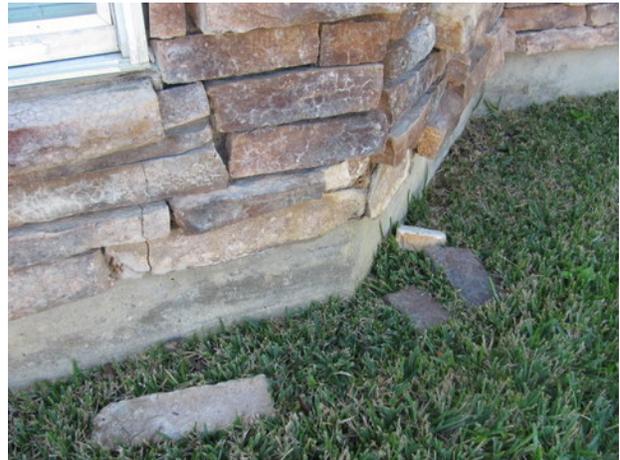
Detached masonry and masonry cracks at building with Unit 7814

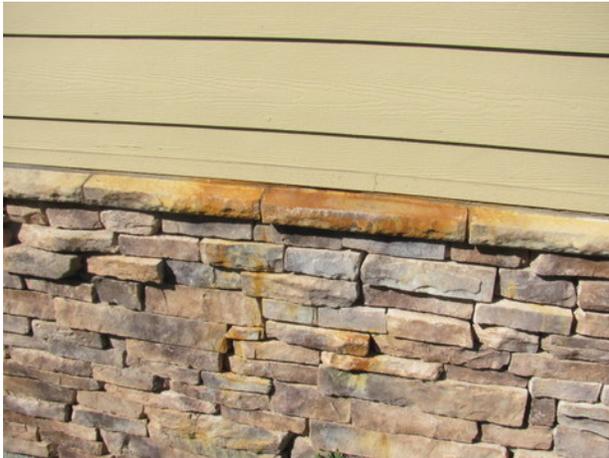
Masonry stains

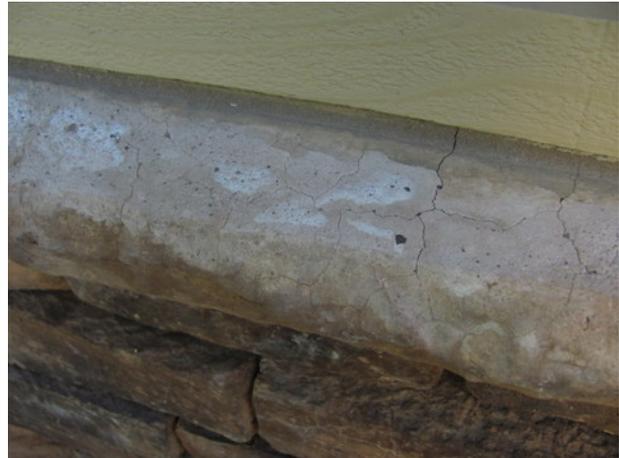
Masonry cracks

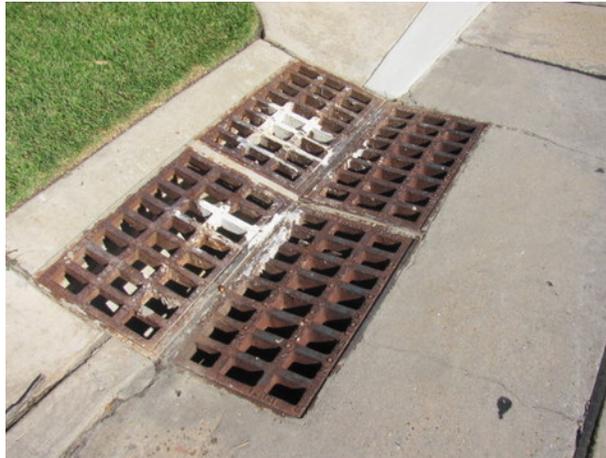
Catch Basins – Twelve concrete catch basins collect storm water from the streets and conduct it into the storm water system. The overall condition of the catch basins is good without settlement visually apparent.

Catch basin

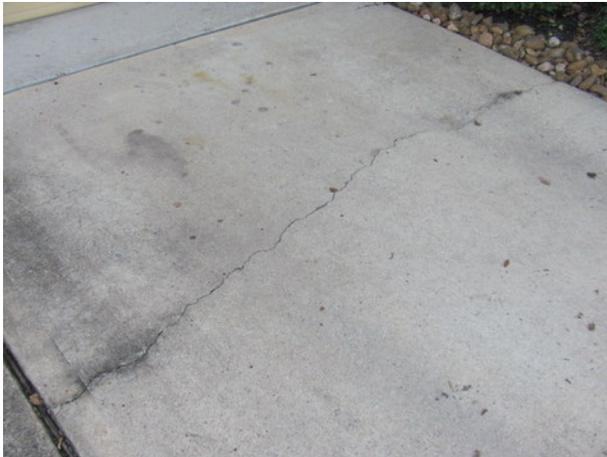
Concrete driveway cracks and deterioration at building with Unit 10843

We estimate that up to 12,540 square feet of concrete driveways, or twenty-five percent (25%) of the total, will require replacement during the next 30 years. We advise the Association budget for the replacement of 2,090 square feet of driveways, every five years beginning by 2021. Line Item 4.120 of *Reserve Expenditures* notes our estimate of future costs and anticipated times of replacements. We base our estimate of replacement on five-inch thick, 3,000 pounds per square inch (PSI) concrete with 6x6 - W1.4xW1.4 steel reinforcing mesh.

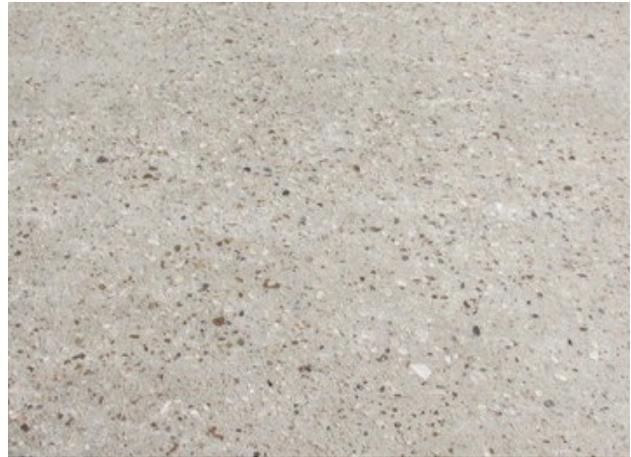
Concrete driveway deterioration at building with Unit 10807

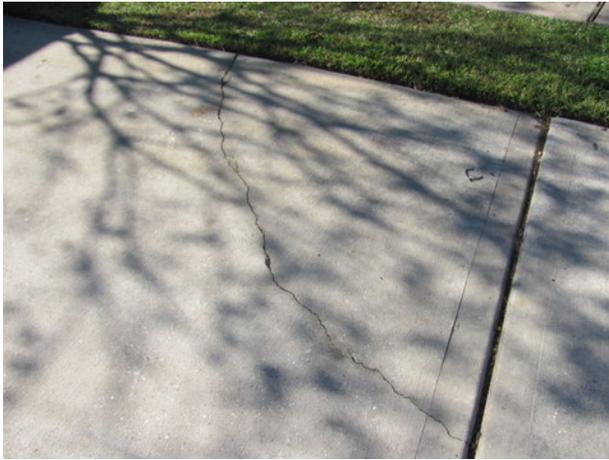
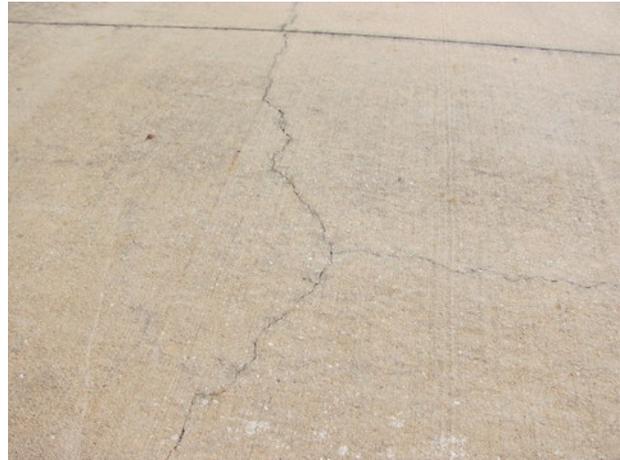
Concrete driveway cracks

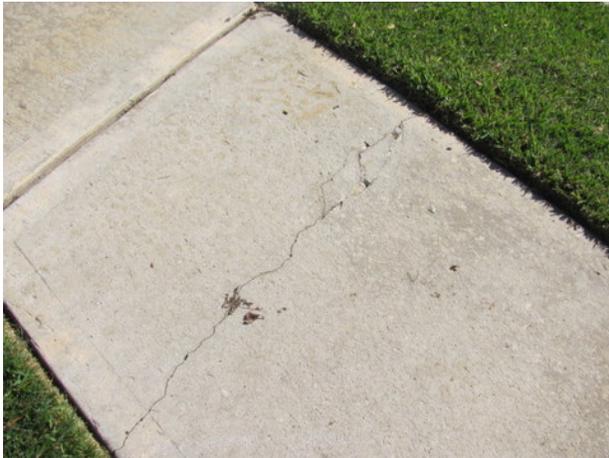
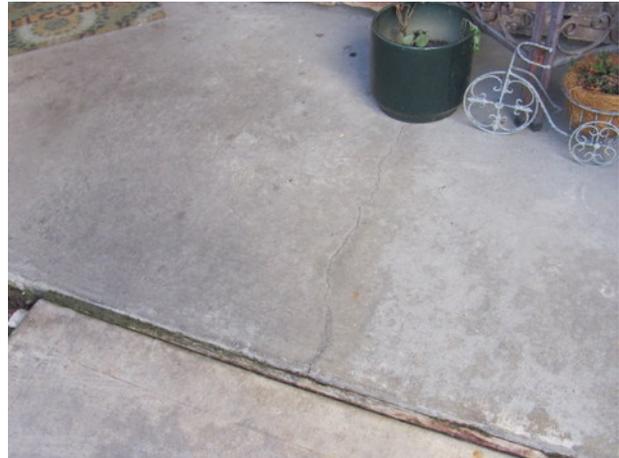
Concrete sidewalk cracks

We estimate that up to 12,690 square feet of concrete sidewalks, or twenty-five percent (25%) of the total, will require replacement during the next 30 years. We recommend the Association budget for replacement of 2,115 square feet of concrete sidewalks every five years beginning by 2021. Line Item 4.140 of *Reserve Expenditures* notes our estimate of future costs and anticipated times of replacements. We base our estimate of replacement on four-inch thick, 3,000 PSI concrete with 6x6 - W1.4xW1.4 steel reinforcing mesh. We recommend an annual inspection of the sidewalks to identify potential trip hazards. We suggest the Association grind down or mark these hazards with orange safety paint prior to replacement and fund this ongoing activity through the operating budget.

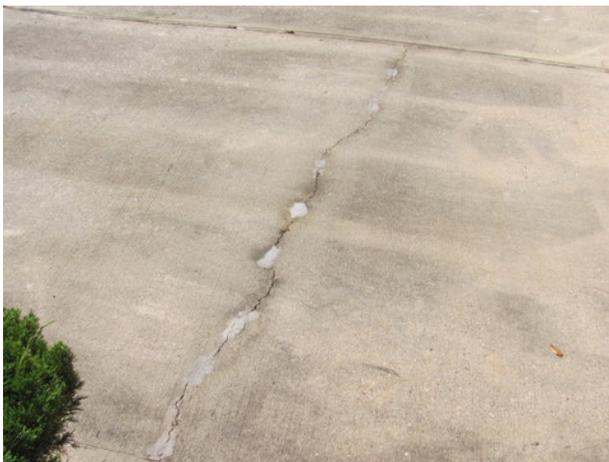
Concrete street cracks and deterioration

Heavy wear from vehicle traffic increases the potential for deterioration. Therefore, concrete streets have a useful life of up to 65 years. We estimate that up to 13,095 square feet of concrete streets, or twenty percent (20%) of the total, will require replacement during the next 30 years. We advise the Association budget for the replacement of 4,365 square feet of the streets every 10 years beginning by 2026. Line Item 4.180 of Reserve Expenditures notes our estimate of future costs and anticipated times of replacements.

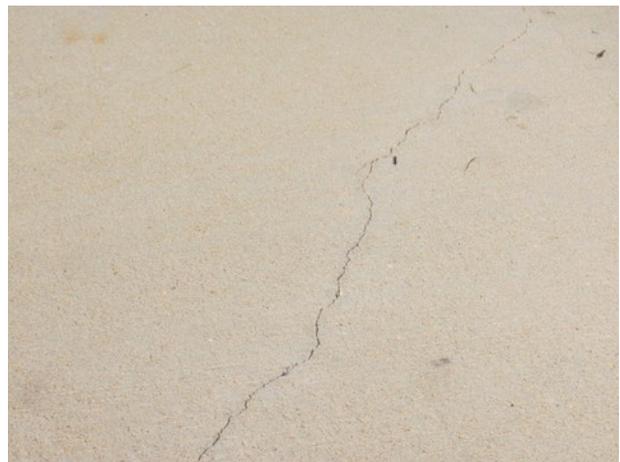
Concrete street cracks

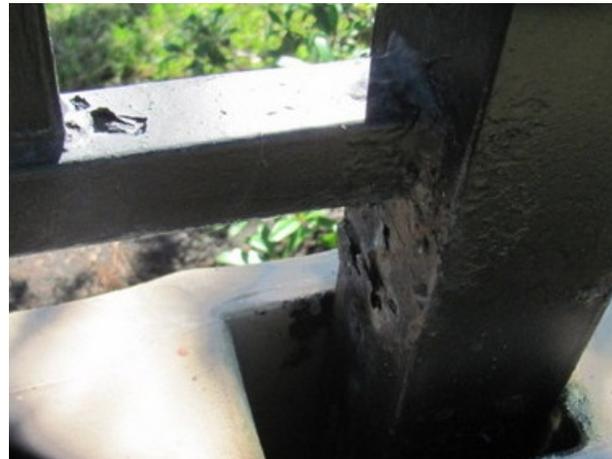
Paint finish deterioration

Periodic applications of paint to the metal will help maximize the useful life. Preparation of the metal before application of the paint finish is important. The paint contractor should remove all soil, dirt, oil, grease and other foreign materials before application of the paint finish to maximize its useful life. The contractor should also remove paint blisters and rust prior to the paint finish application. We recommend the use of a power wire brush, scraper and/or sander as effective means of removal. The Association should require the application of a primer on bare metal. The primer for metal surfaces should include a rust inhibitor for added protection. We recommend the Association refinish the fences by 2021 and every six years thereafter except when replacement occurs. We anticipate replacement by 2033. We depict this information on Line Items 4.240 and 4.245 of *Reserve Expenditures*.

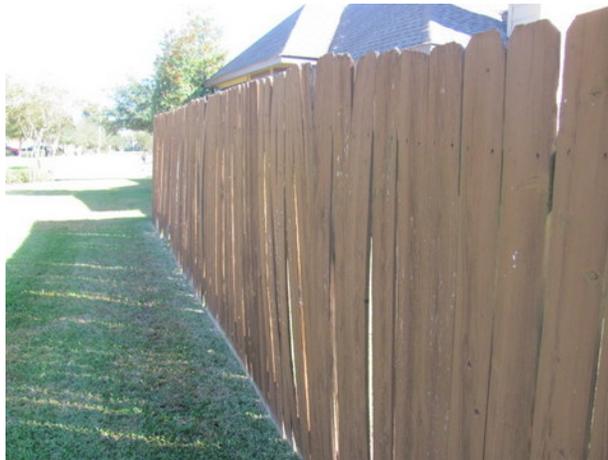
Fences, Wood - Approximately 2,100 linear feet of wood fences are found at the rears of the units. The fences between each unit are maintained by the homeowners. The fences are original and in fair to poor condition.

Wood fence at unit rear

Wood fences of this type have useful lives of 15- to 20-years. The Association should anticipate periodic partial replacements due to the non-uniform nature of wood deterioration. Along with these partial replacements, the Association should apply periodic paint applications as needed and fund these activities through the operating budget. We suggest the Association plan for a phased replacement beginning by 2017 and concluding by 2018. A subsequent phased replacement is likely beginning by 2037 and concluding by 2038. We depict this information on Line Item 4.285 of *Reserve Expenditures*.

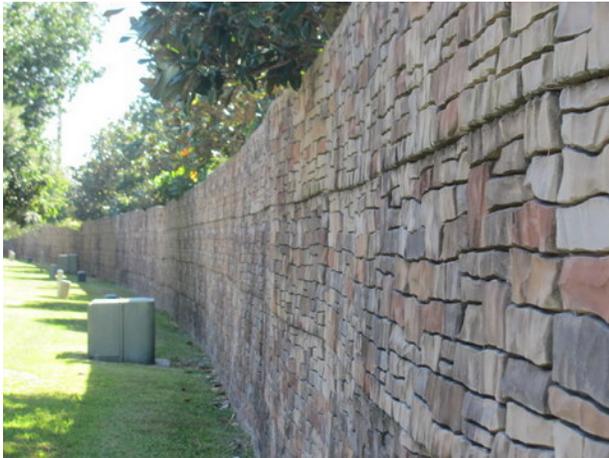
Vinyl perimeter wall overview with deflection evident

These walls comprise vinyl panels and do not utilize a foundation for support. Rather, the panels are supported internally typically with wood frames. These types of walls are prone to damage and deflection. Based on the type of walls we anticipate a useful life of 20-to 25- years. We suggest the Association budget for replacement of the walls by 2024. We depict this information on Line Item 4.640 of *Reserve Expenditures*. To maximize the useful life of these walls, the Association should direct irrigation system heads away from the walls and ensure tree roots do not undermine the support columns.

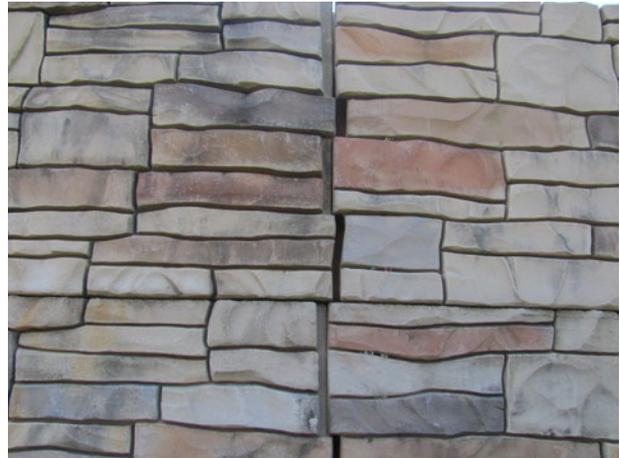
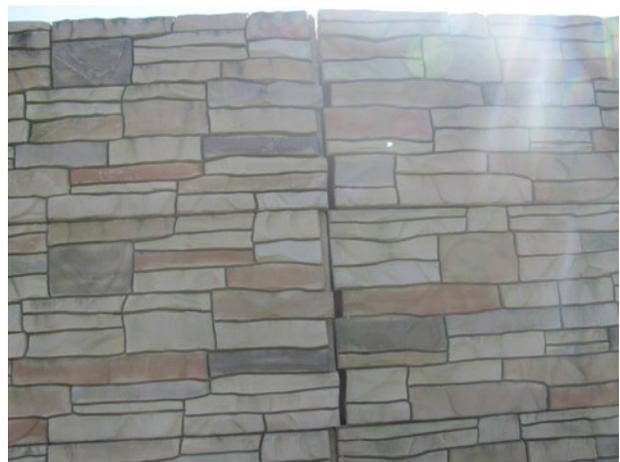
Gaps in vinyl perimeter wall

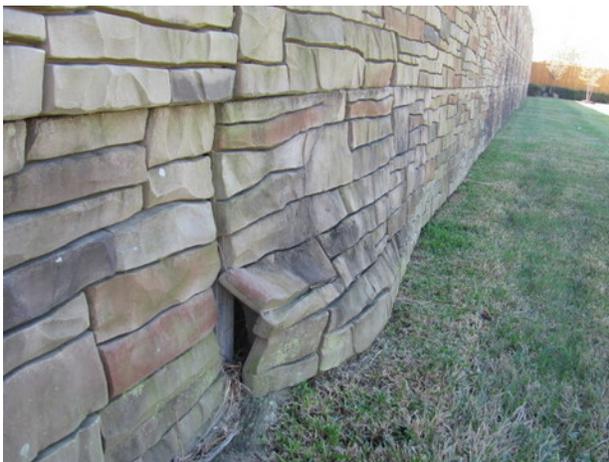
Vinyl perimeter wall damage
