Revised
FULL RESERVE STUDY
Heron Lakes
Townhome Association, Inc.

Houston, Texas
Inspected - November 15, 2016
Revised - March 24, 2017

Client: Heron Lakes Townhome Association, Inc. (Heron Lakes)

Reference: 060490

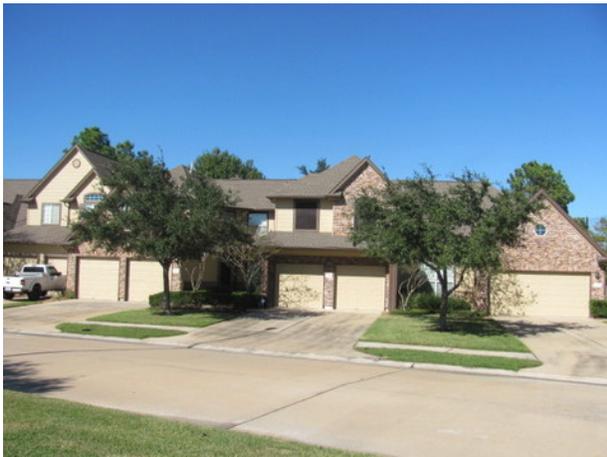
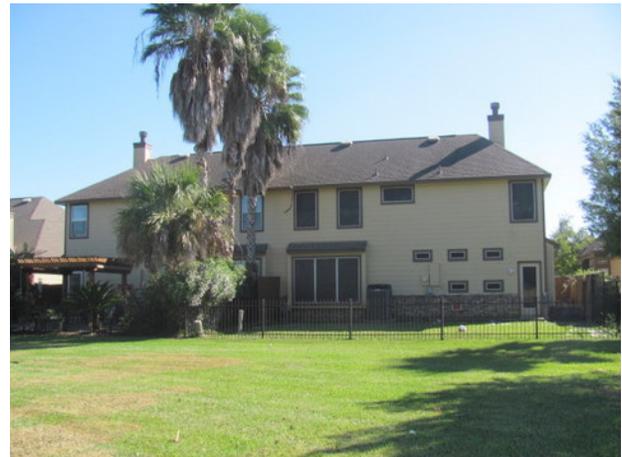
Chimney Caps, Metal - Heron Lakes maintains 84 metal chimney caps. The chimney caps are original and in good overall condition based on our visual inspection from the ground.

Chimney caps of this type have useful lives of up to 25 years. We recommend the Association anticipate a phased replacement of the chimney caps and related flashing beginning by 2027 and concluding by 2028 in coordination with the roofs. We depict this information on Line Item 1.140 of *Reserve Expenditures*. We recommend the Association inspect the condition of the chimney caps concurrent with replacement of the roof systems.

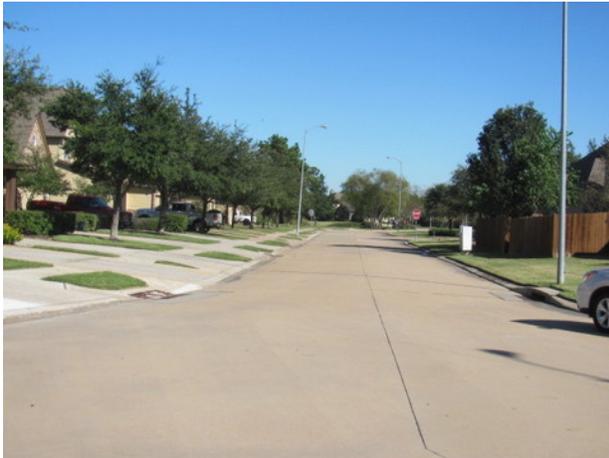
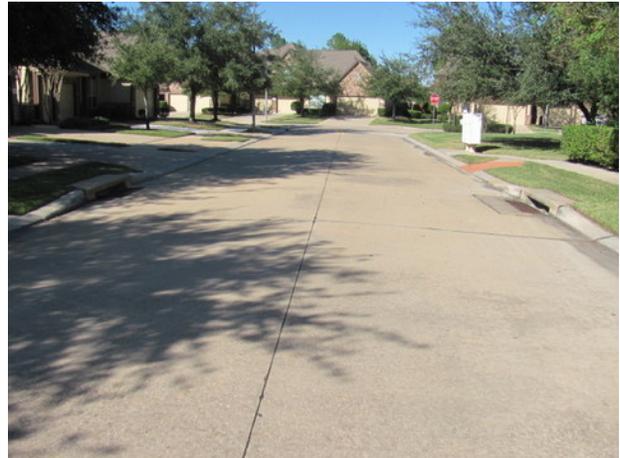
Concrete Streets - The Association maintains approximately 65,500 square feet of concrete at the private streets. The streets are original and in good overall condition. We note concrete cracks and deterioration.

Concrete street overview

The Association should coordinate the concrete flatwork partial replacements on Line Items 4.120 through 4.180 of *Reserve Expenditures* to maximize the given amount of concrete in a single event. This will permit the use of a single contractor and likely achieve the most economical unit price for the work. The times and costs of these replacements may vary. However, the estimated expenditures detailed in *Reserve Expenditures* are sufficient to budget appropriate reserves.

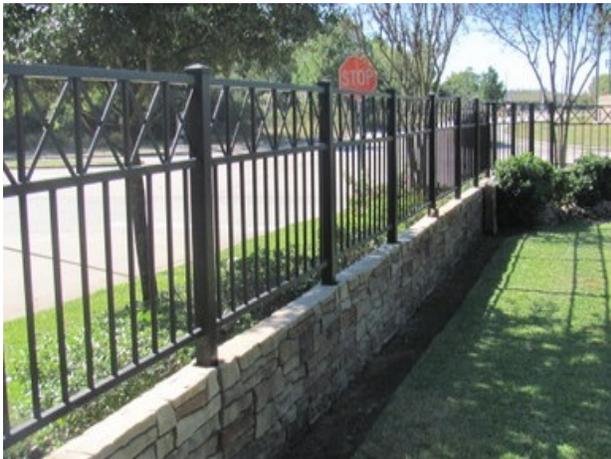
Fences, Metal - Approximately 1,580 linear feet of metal fences are found throughout the property. The homeowners are responsible for the fences between the units. The fences are original and in good condition. The protective finishes are in fair overall condition at an age of one year. We note isolated paint finish deterioration.

Metal fence overview

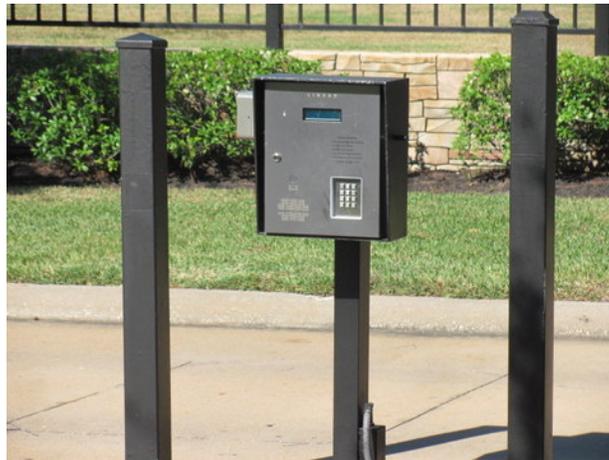
Gate Entry System - The Association utilizes one gate entry system intercom panel for communication between the units and guests at Heron Lakes. Management informs us the panel in good operational condition at age of one year.

Gate entry panel

Gate entry system intercom panels of this type have useful lives of 10- to 15-years. We recommend the Association anticipate replacement by 2027 and again by 2039. We depict this information on Line Item 4.310 of *Reserve Expenditures*.

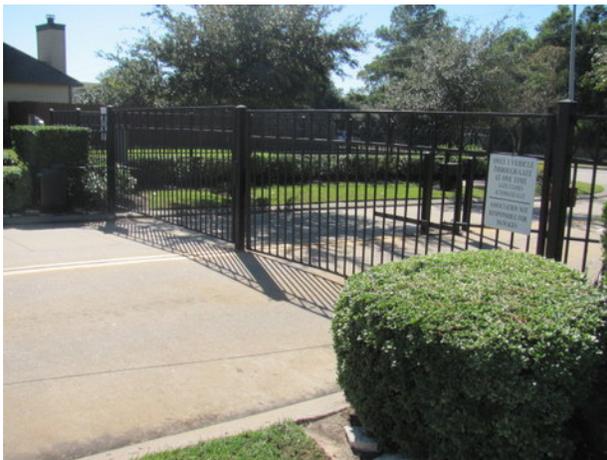
Gates and Operators - The two metal gates and two bi-parting operators limit access into the community. The gates are original and in good condition, and the operators are in good condition at one year of age.

Entrance gates

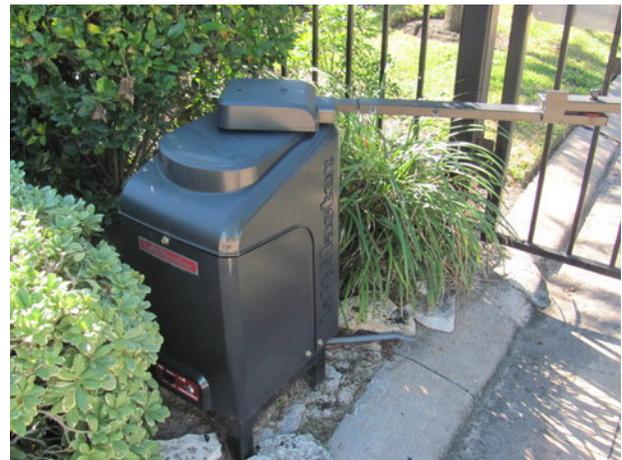
Gate operator

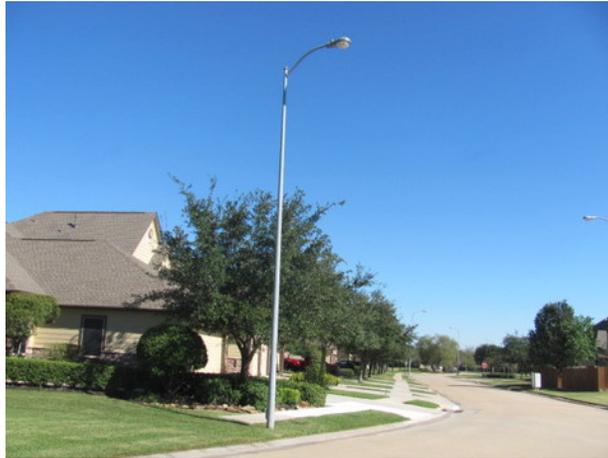
Light Poles and Fixtures - The Association uses 16 metal light fixtures atop metal poles to illuminate the property. These elements are original, in good condition and have useful lives of up to 30 years.

Light pole and fixture

The Association should anticipate the need for replacement by 2031. We note this information on Line Item 4.560 of *Reserve Expenditures*.

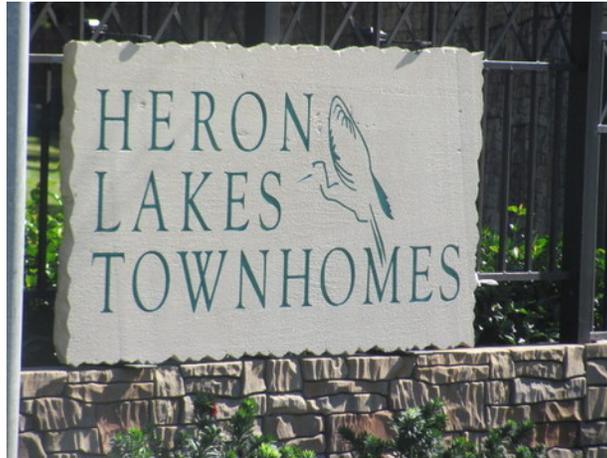
Signage - The Association maintains two stone property identification entrance monument signs. One sign is original and one was recently replaced due to damage.

Entrance signage

The functional useful life of these signs is from 15- to 20-years. Community signage contributes to the overall aesthetic appearance of the property to owners and potential buyers. Renovation or replacement of community signs is often predicated upon the desire to "update" the perceived identity of the community rather than for utilitarian concerns. Therefore, the specific times for replacement or renovation are discretionary. We recommend the Association plan to replace the signage by 2025 and again by 2045. We note this information on Line Item 4.810 of *Reserve Expenditures*. The Association should fund interim repairs and replacements through the operating budget.
